Prevention of Occupational and other Accidents During Cargo Related Operations Onboard

Research based suggestions to eliminate accidents during cargo related operations onboard ships

Shane Sankaranarayana

21st February 2022

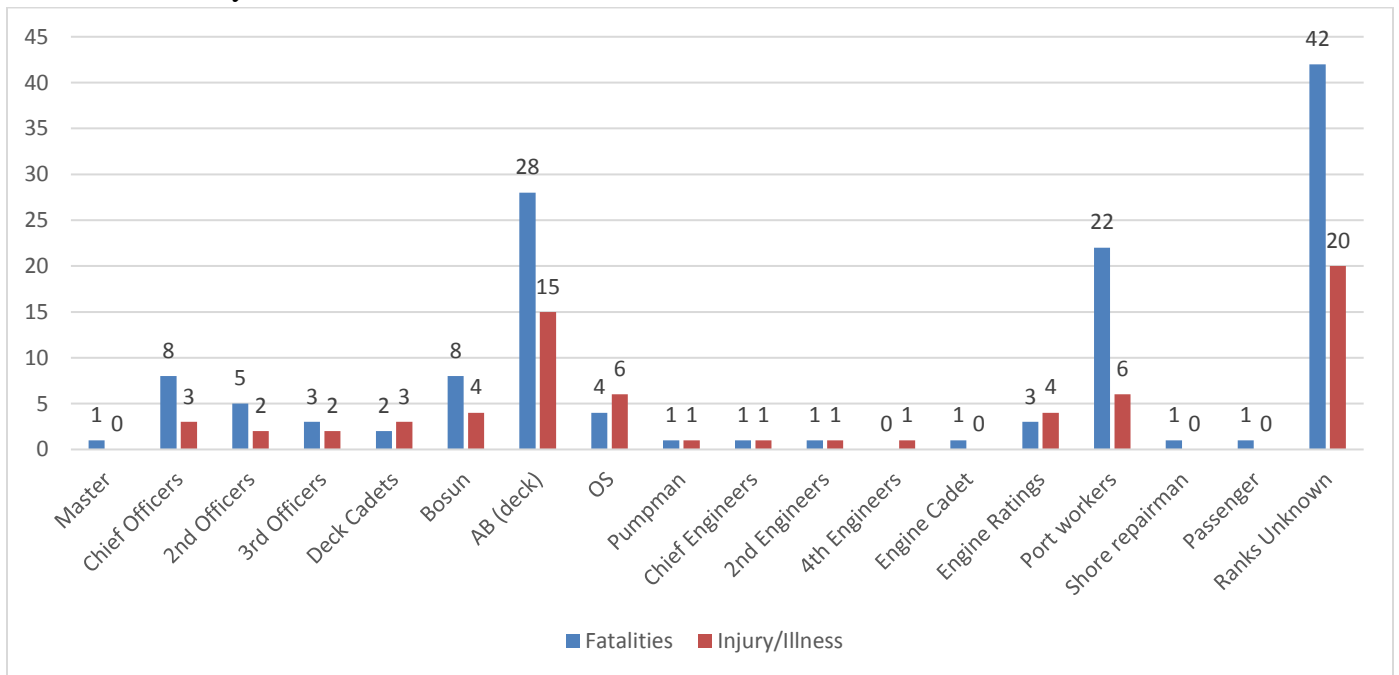
To reduce the complication of the Graph – 3 (below), some ranks which were mentioned in accident investigation reports are merged as below:

- Chief officers include one ‘Apprentice Mate’. It was not very clear about the certification of the Apprentice Mate, but because of the name ‘Apprentice Mate’, he is included in the Chief officer’s category.
- Engine ratings include oilers, motormen and engine fitters.
- Deck cadets include deck cadets and one AO (Apprentice Officer). It was not very clear about the certification of the AO, but because of the name ‘Apprentice Officer’, he is included in the Deck Cadet’s category.
- AB (deck) include:
 - 02 carpenters (certified as Able seafarer deck) and
 - 01 painter (well experienced with deck work)
- Port workers include:
 - 22 stevedores
 - 01 crane operator
 - 01 signalman
 - 01 cargo inspector
 - 01 supervisor
 - 01 foreman and
 - 01 tallyman

Ranks involved with injuries and fatalities

The fatalities and injuries mentioned in the above Graph – 3 had taken place during 94 accidents which occurred onboard 94 ships. Apart from these 94 occupational accidents there were 18 accidents which only caused material damages (cargo or ship damages) without any injuries.

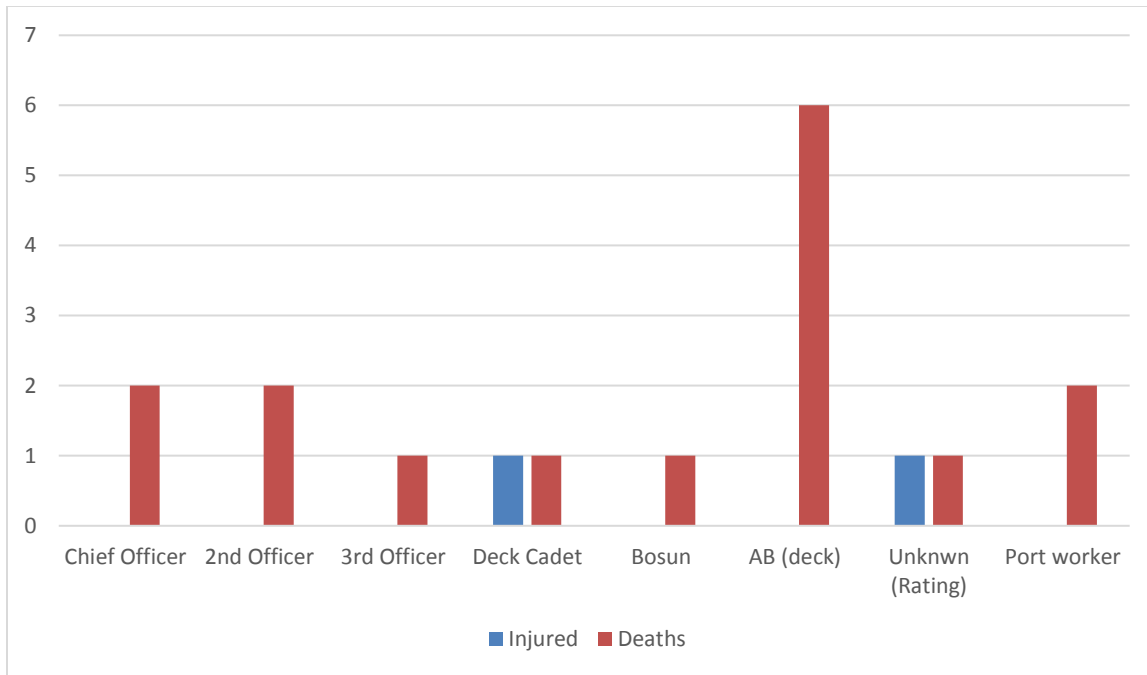
Following ranks were injured and had died due to the total of 17 accidents occurred on all types of ships:

Ranks injured & died due to falling while walking/working aloft
Graph - 9

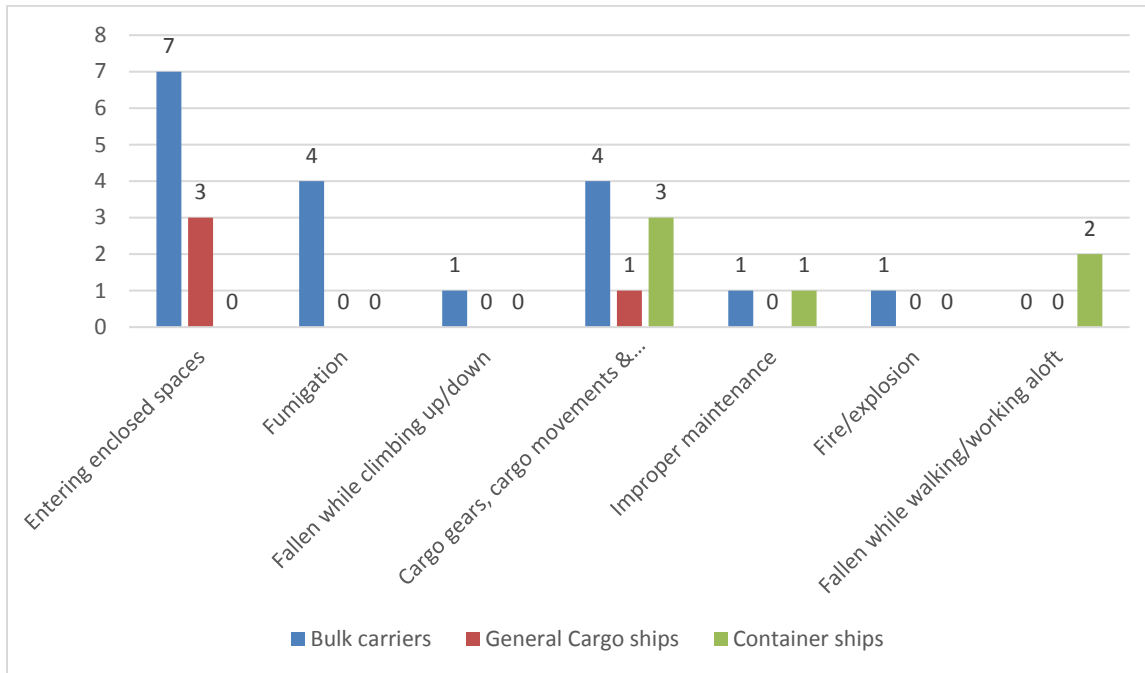
Graph – 11

Some of these accidents could have been avoided if the port workers cooperated with the ship's staff or if the ship staff managed to take reasonable precautions beforehand to eliminate the risks. 22 port workers had died and 6 were injured due to 18 accidents during cargo operations. The types of the accidents and the types of ships are as follows:

Deaths/injuries of port workers

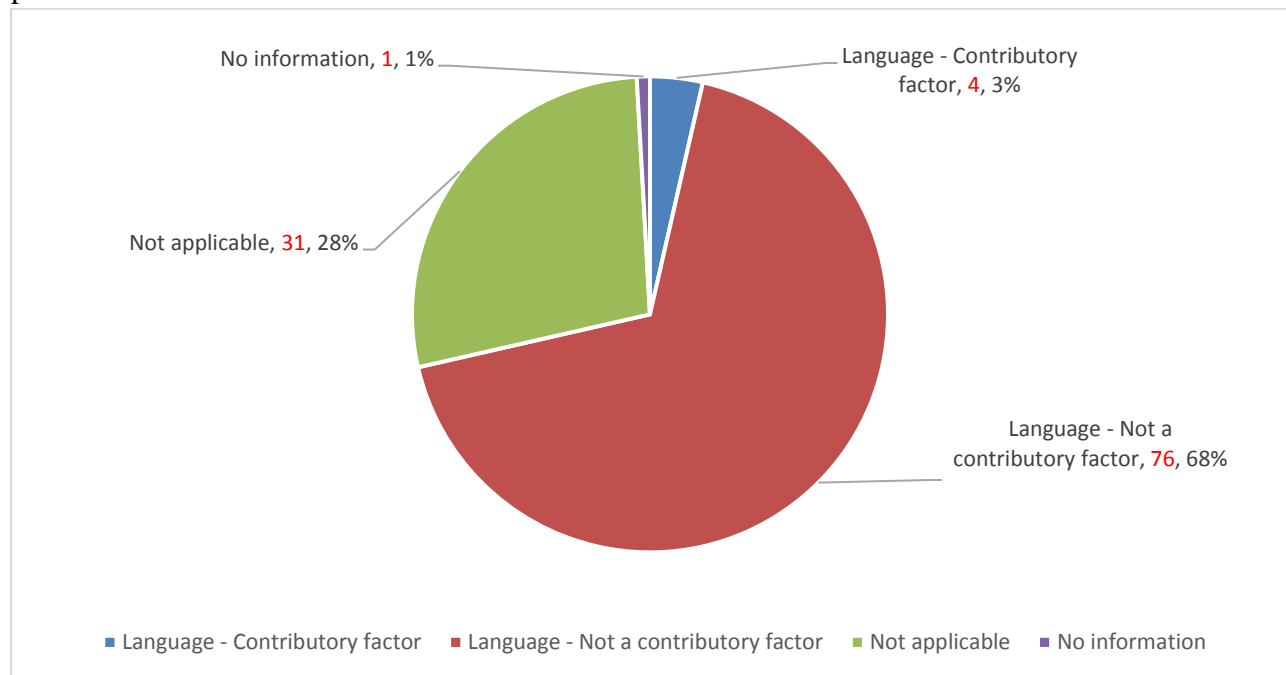
Graph – 12

It is not clear whether it is because of the use of SMCP or the use of native languages onboard, the language barrier was not a major problem in cargo related accidents onboard ships during the period considered.

Language barrier as a contributory factor

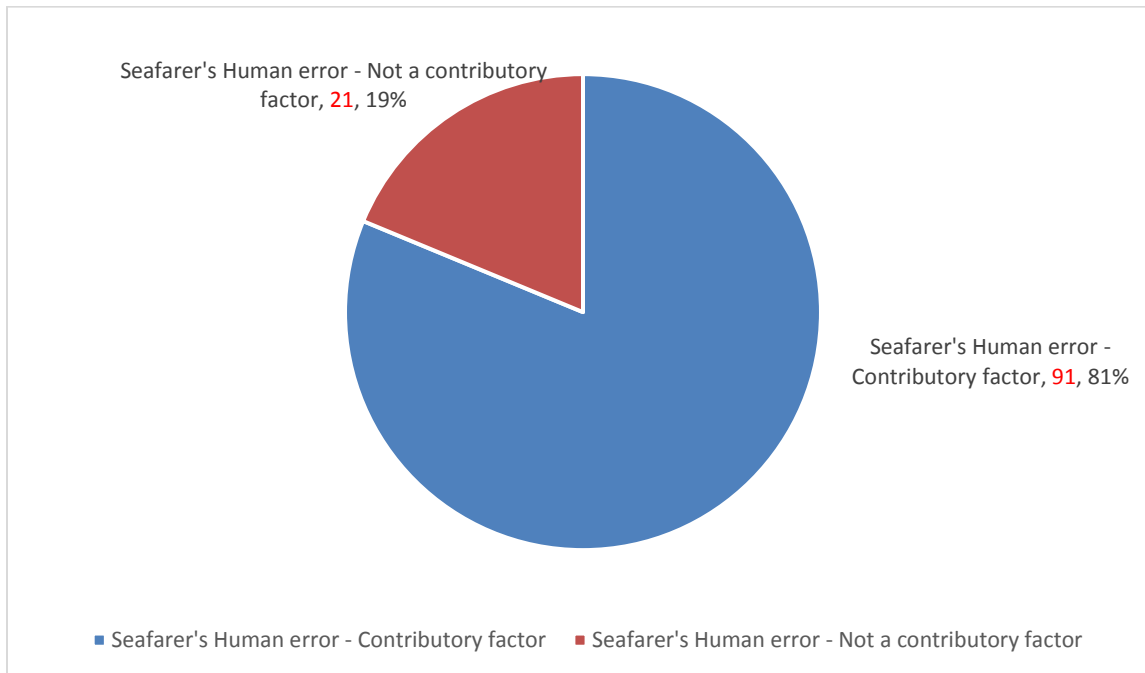
Graph - 13

81% of the cargo operations or cargo related accidents had taken place due to the onboard staff’s human error.

Human error as a contributory factor

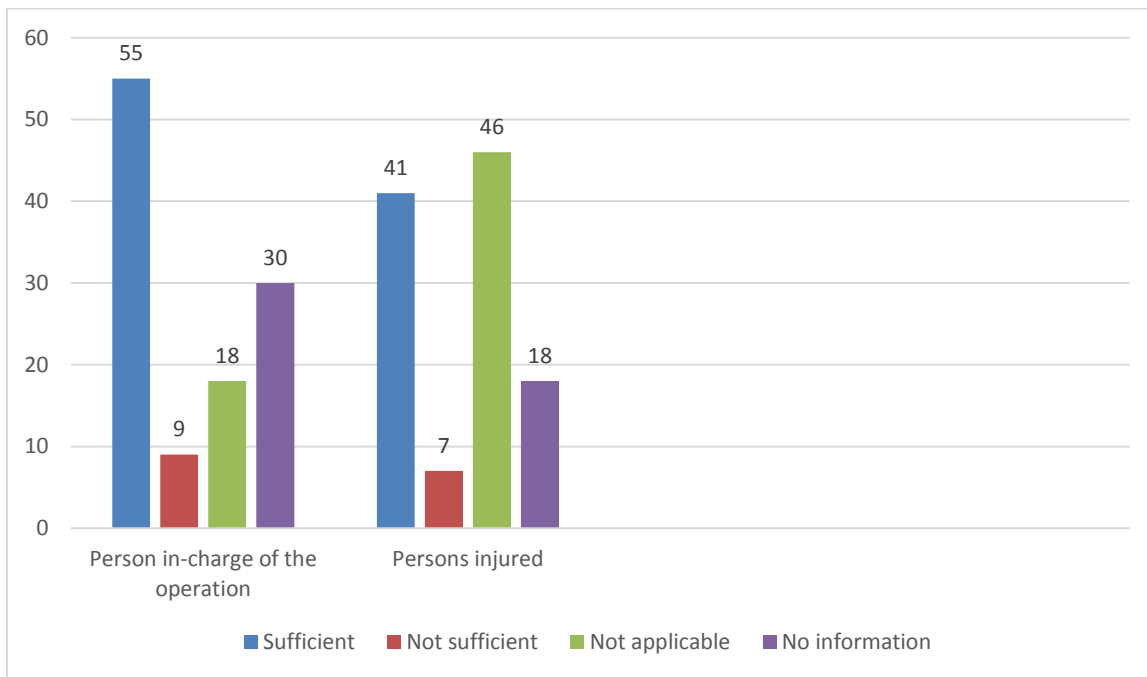
Graph – 15

Experience of the seafarers with the rank

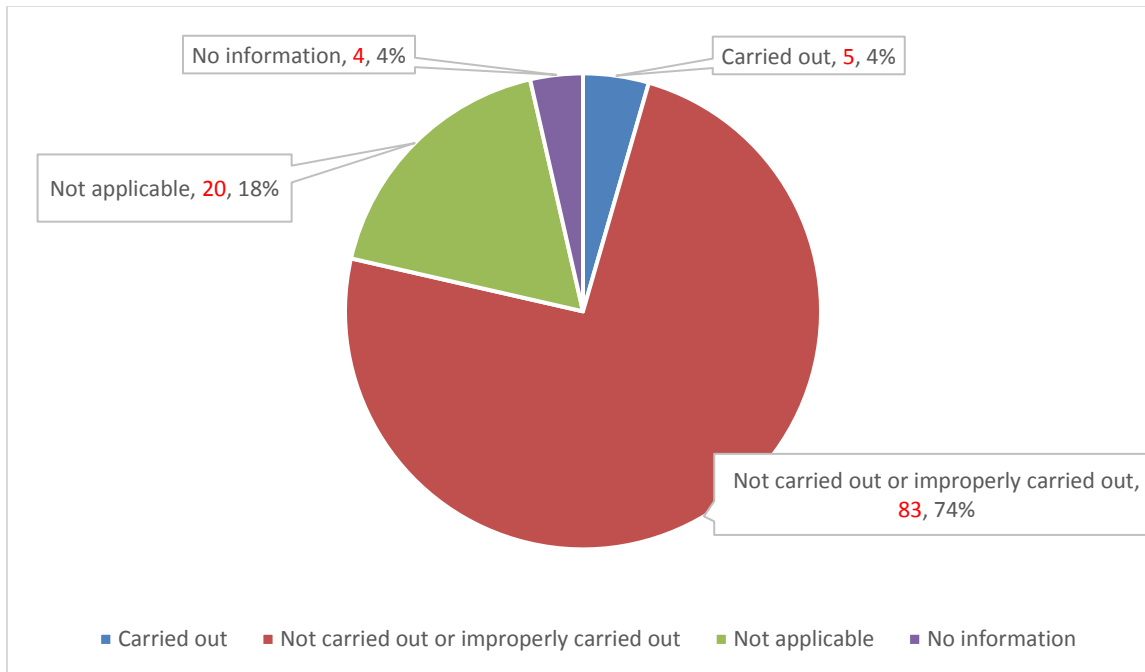
Graph – 18

It is very sad to note that in 83 cases out of the 112 cargo related accidents, no risk assessments were carried out or the risks assessments were not properly carried out.

Proper risk assessments were carried out only in 5 accidents (4 % of total accidents).

Risk assessment conducted before the accident

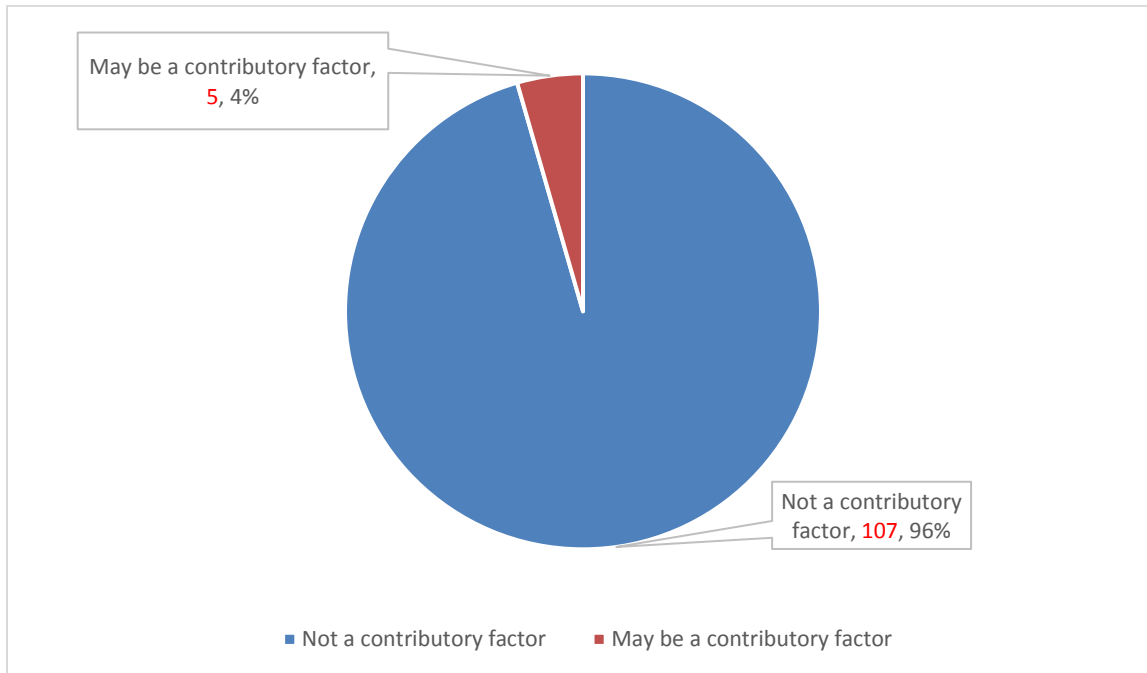
Graph – 20

Alcohol abuse as a contributory factor

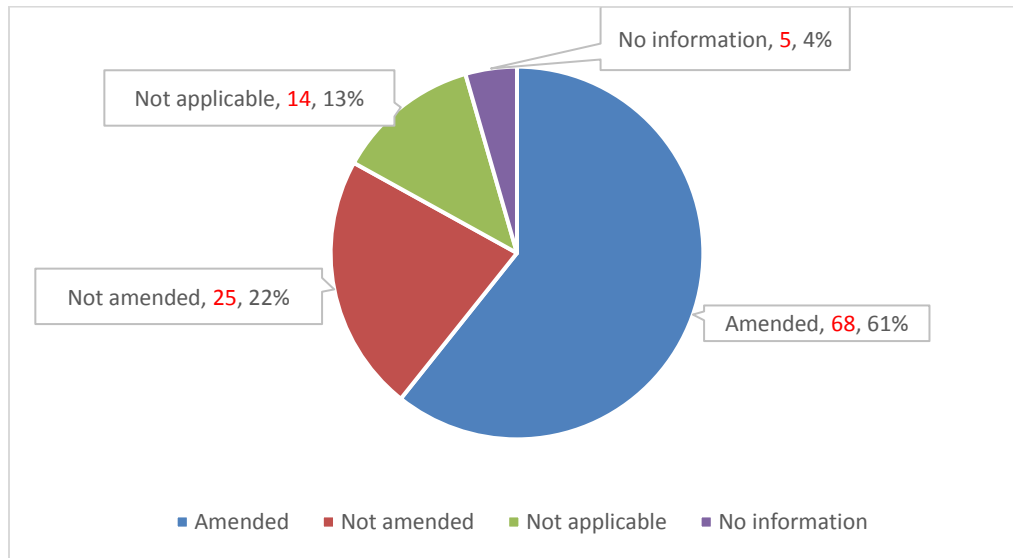
Graph – 22

Amendments to the existing SMS after accidents

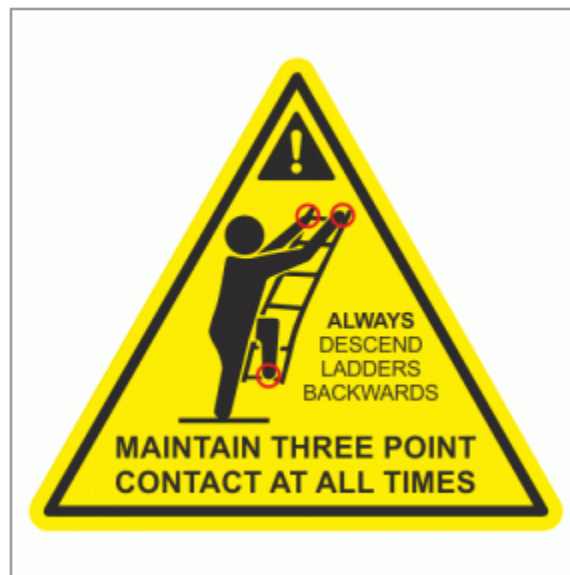
Figure - 2

The industry needs to promote the use of ‘three-point contact’ in the maritime sector. At the moment, this is practiced only by some ship owners but not all. Better to have a common safety sticker (as below) posted, next to the vertical ladders (at the entrance and exit points both) to remind the use of three-point contact:

Three-point contact sticker [46]
